# File:Photo 3.1.jpg

A regulator draining excess water from Polder 31-part into the Kazibacha River

The wiki version of the Lessons Learnt Report of the Blue Gold program, documents the experiences of a technical assistance (TA) team working in a development project implemented by the Bangladesh Water Development Board (BWDB) and the Department of Agricultural Extension (DAE) over an eight+ year period from March 2013 to December 2021. The wiki lessons learnt report (LLR) is intended to complement the BWDB and DAE project completion reports (PCRs), with the aim of recording lessons learnt for use in the design and implementation of future interventions in the coastal zone.

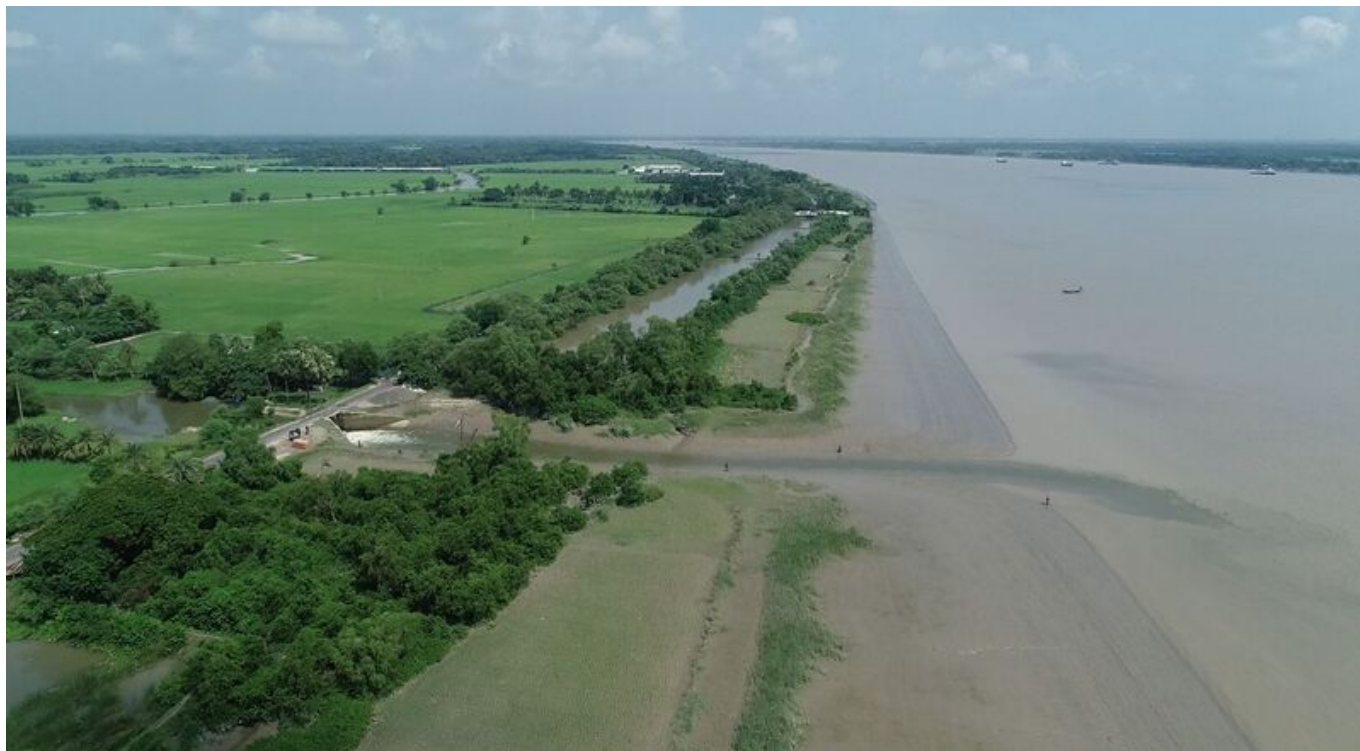
the principal function of a regulator or drainage sluice is to allow the drainage of water from the polder into a peripheral river when there is a differential head across the regulator (ie when the polder or country-side water level exceeds the level in the tidal river). The regulator is provided with a lift gate on the country-side (to allow freshwater to be held in the khal for irrigation during the dry season) and a flap gate on the river-side (to prevent water entry from the river channel into the polder during high tide conditions). A frame is provided on the river-side so that the flap gate can be lifted when there is freshwater in the river (during the monsoon flood season), thus allowing freshwater to be stored in the khal within the polder and used for irrigation during the dry season. The size of the culvert is determined from the drainage area served by the structure.
